Monitoring Radar Mechanical Drive Systems

FAA's choice of monitoring solutions

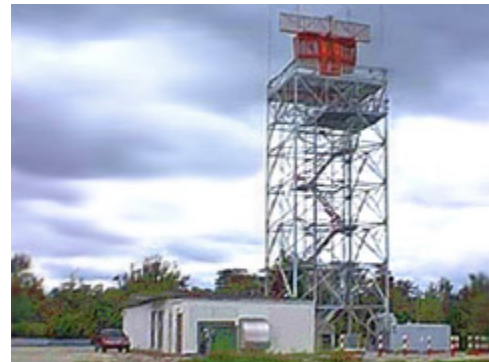
Figure 1. ASR-9 radar tower

Ask the public to name mission-critical systems, and air traffic control radar will be at the top of the list. The FAA utilizes Airport Surveillance Radar (ASR-9) systems, such as the one shown in Figure 1 at the right, to control incoming and outgoing air traffic at high density US airports and support facilities. The other primary radar for commercial air traffic control is Airport Surface Detection Equipment (ASDE-3) radar, normally installed on top of an airport traffic control tower. ASDE-3 systems manage ground traffic at larger airports across the country and are critical when weather is bad and visibility is poor.

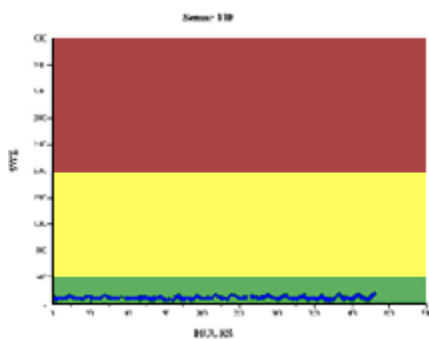
Figure 3. SWE history from ASR-9 right side motor shows healthy operating condition.

In Figure 3, the right side motor shows a low, stable SWE level. A quick glance shows that the machine's condition is clearly in the green zone, trending steady, and it is in healthy operating condition. Figure 4 tells a different story. The left side motor shows elevated Stress Wave Energy, with extremely erratic and upward trending. The SWE levels are in the yellow zone, spiking into red. A quick glance at this chart clearly shows the motor is in distress.

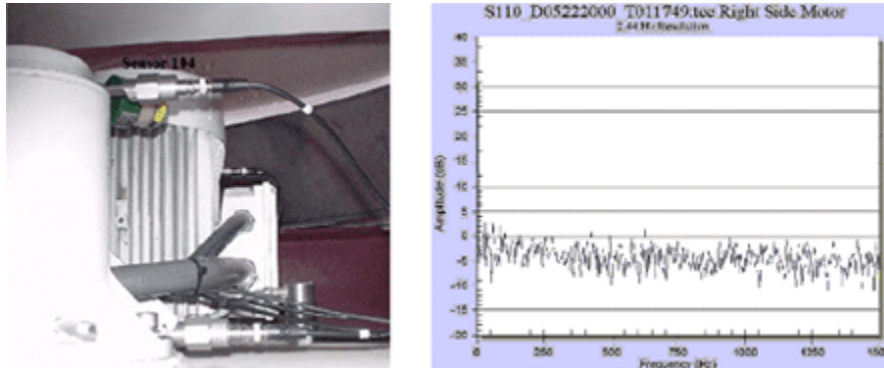
Figure 6 shows Spectral Analysis for the right side motor, with a low noise floor and no significant spectral peaks. Spectral Analysis for the left side motor, shown in Figure 7, has a slightly raised noise floor with significant spectral peaks at 107Hz. The elevated background noise confirms increased friction levels, and the frequency peak at 107Hz is consistent with the fault frequency for the motor bottom bearing. Thus, SWAN technology was able to identify the damaged element without having to first take the unit out of service.

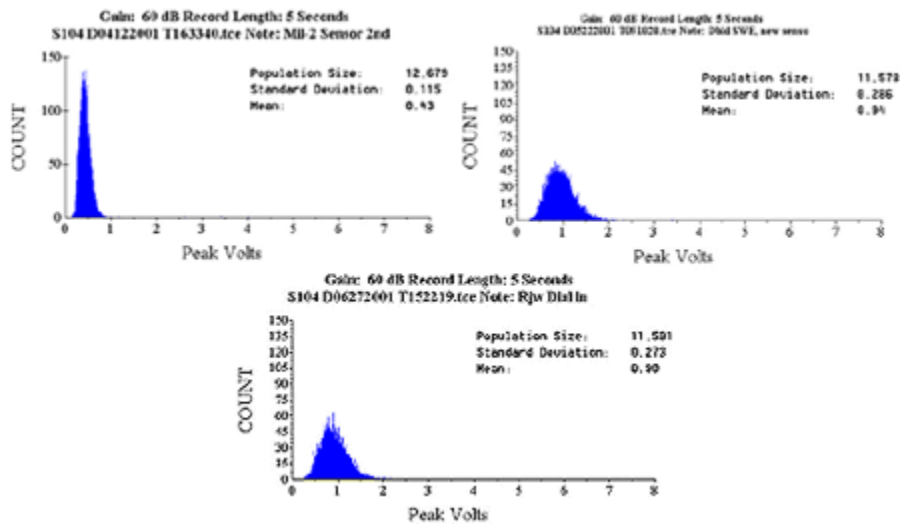
Figure 8 shows three Stress Wave Amplitude Histograms taken from the bottom sensor on the intermediate shaft. The histogram at the top shows a relatively tight bell shaped curve with a MEAN value of .43 peak volts.

The Stress Wave Analysis Histogram in the middle of Figure 8 shows that, 30 days later, the

sensor has begun to detect a slight increase in friction. The histogram is still a relatively tight bell-shaped curve; however the mean has shifted from the baseline of .43 peak volts to a new mean value of .94 peak volts.

The histogram at the bottom of Figure 8, taken 60 days after installation, shows that Stress Wave Energy continues in a relatively tight bell-shaped curve. The mean, at .90 peak volts, and standard deviation show that the damage has not progressed beyond what was seen at 30 days. In this case, SWAN tools allow maintenance personnel to keep an eye on the developing fault, but not take the equipment out of service until necessary.

Figure 8. Stress Wave Amplitude Histograms taken at installation (top), 30 days later (middle), and 60 days later (bottom) show the beginnings of an early stage fault in the intermediate shaft.

The Stress Wave Operating History charts from the sensors on the intermediate shaft started out in the green zone. However, SWE levels began climbing into the yellow zone about 30 days after installation, indicating an early stage fault. A look at Stress Wave Amplitude Histograms provides additional information on the intermediate shaft's health.
